# Levee and Floodwall Observation Sheet

Location (parish, area) in which incident is occurring: Orleans Parish, East Bank Lakefront, Map ID L88

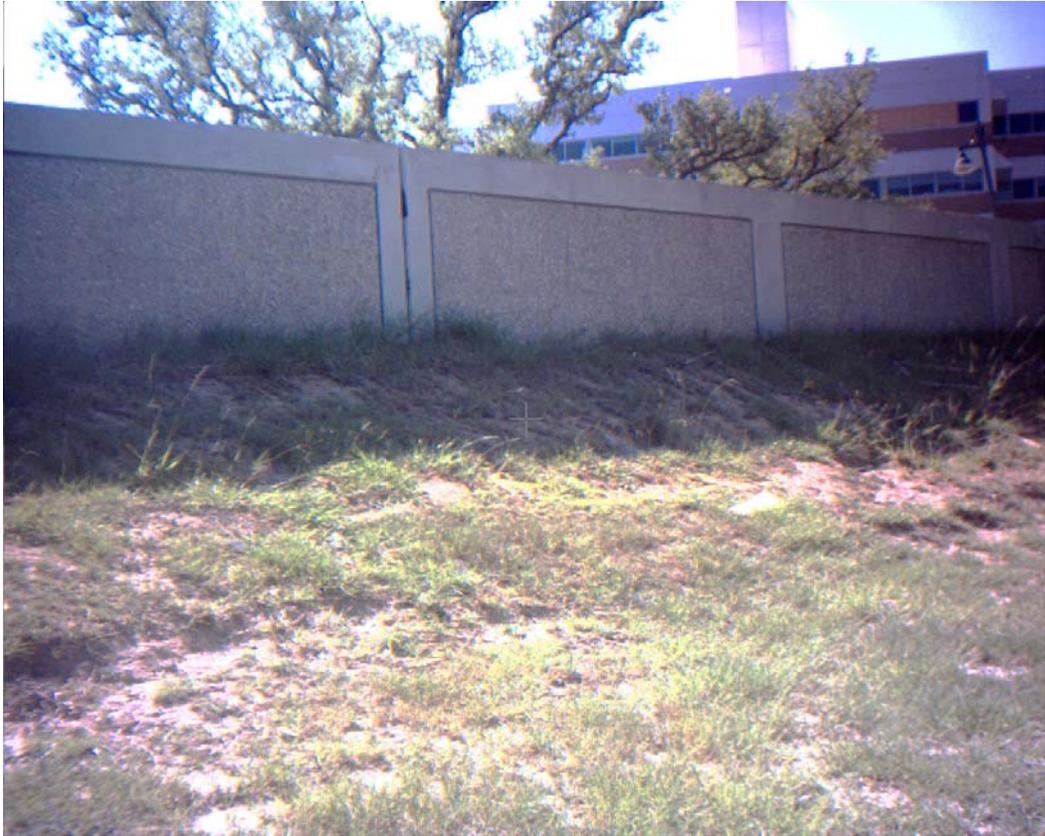
**C. Photo Numbers:** PHOTO ATTACHED

<i>Select one</i>	<b>Class</b>	<b>Descriptor</b>	<b>Description of Scour</b>
<input checked="" type="checkbox"/>	I	Light	Scour from crown 2 feet down slope
<input type="checkbox"/>	II	Heavy	Scour from crown to ground surface
<input type="checkbox"/>	III	Breach	Scour below ground surface

Comments: Shallow erosion – width: 15 ft and depth: 0.5 ft.
